# **FATIGUE STRENGTH RESTORATION IN CORROSION PITTED 4340 ALLOY STEEL VIA LOW PLASTICITY BURNISHING**

John T. Cammett\* and Paul S. Prevey  
Lambda Research, Cincinnati, OH

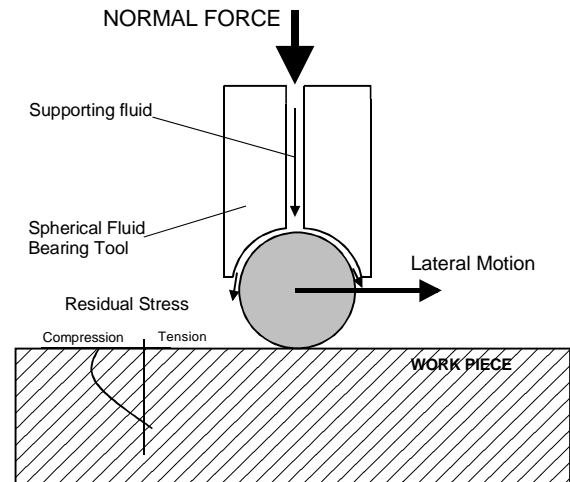
**Figure 1** - Low Plasticity Burnishing schematic.

The concept of low plasticity burnishing (LPB) originated as a means of producing a layer of compressive residual stress of high magnitude and depth with **minimal** cold work.<sup>13</sup> The process typically involves a single pass of a

smooth free rolling spherical ball under a normal force sufficient to plastically deform the surface of the material, thereby creating a compressive layer of residual stress. The process is shown schematically in Figure 1. The ball is supported in a fluid bearing with sufficient pressure to lift the ball off the surface of the retaining spherical socket. The ball is in mechanical contact only with the surface to be burnished and is free to roll on the surface of the work piece.

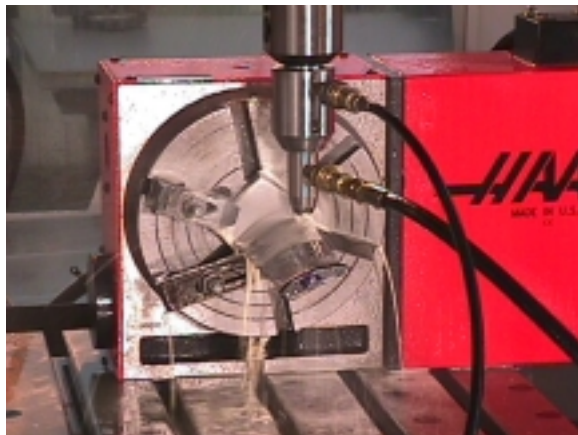
**Figure 2** - LPB tool being used in four-axis mode while performing LPB on a compressor blade in a 20 HP vertical CNC mill.

The LPB tool designed to fit a CAT-40 tool holder in a Haas 20 HP vertical CNC mill is shown in four-axis operation in Figure 2. The quill of the machine is not rotated. The swivel links in the hydraulic hose allow exchange of the

tool to and from the tool holder so that LPB processing can be incorporated into standard machining sequences in existing CNC machine tools. Injection of the fluid through the quill of the mill is also possible in a suitably equipped machine. With minor modification, the apparatus can be adapted to most horizontal and multi-axis mills, or lathes.

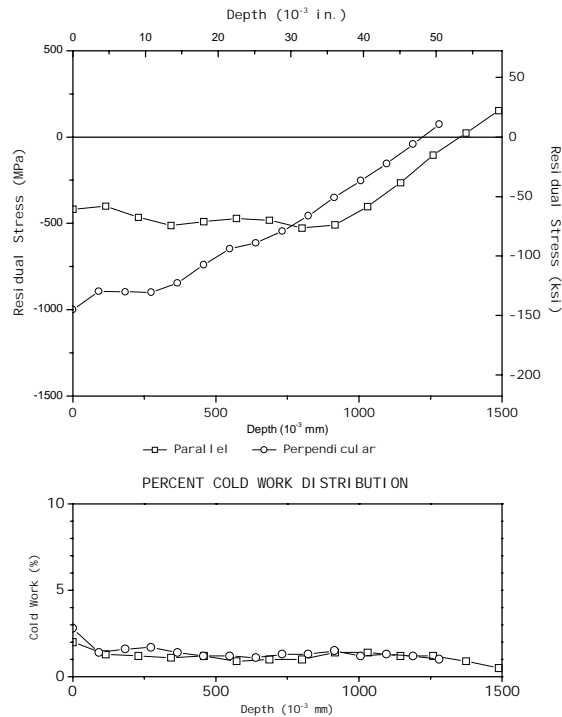
**Figure 3** - Residual stress-depth and percent cold work-depth distributions produced by LPB (4340 Steel).

Figure 3 shows typical residual stress-depth distributions developed by LPB of the 4340 alloy steel, 38 HRC in this investigation. LPB parameters were developed using Taguchi analysis in a designed experiment to optimize compressive residual stresses and total depth of compression.<sup>21</sup>

Residual stress-depth results in Figure 3 show differences based on orientation to the direction of ball travel. As has been experienced in other LPB work<sup>9,10</sup> by the authors, greater compression is developed perpendicular to the ball path than parallel to the ball path at the surface and to a considerable depth below. At greater depths the relative compression magnitudes were opposite while the depth of compression was greater parallel to the ball path. These effects occur as a result of the directionality of plastic deformation created in the LPB process. Overall the depth of compression in both directions, 1.2 - 1.4 mm (0.05-0.06 in), was at least three times greater than can normally be achieved via shot peening a material of this hardness at 0.25-0.38 mm (0.010-0.014 in) A intensity<sup>22</sup>.

The ball travel direction in the current work was always perpendicular to the specimen longitudinal plane of symmetry. Thus, the component of greater compressive residual stress magnitude was oriented in the same direction as the principal applied stress during bending fatigue testing.

Also shown in Figure 3 is the cold work-depth distribution resulting from LPB. As may be seen, the amount of cold work was generally small (< 3%) as is desirable in LPB. The maximum cold work at the surface was only very slightly greater than at any subsurface depth.

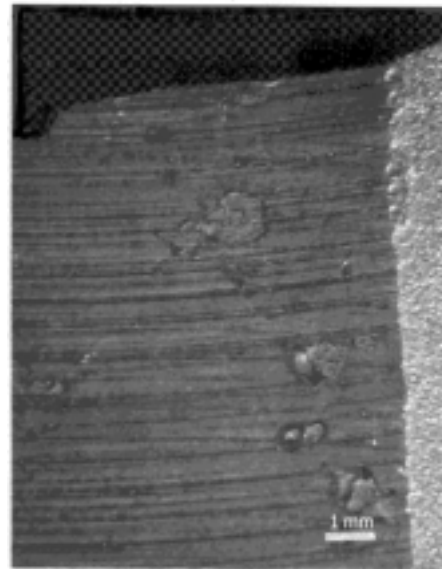
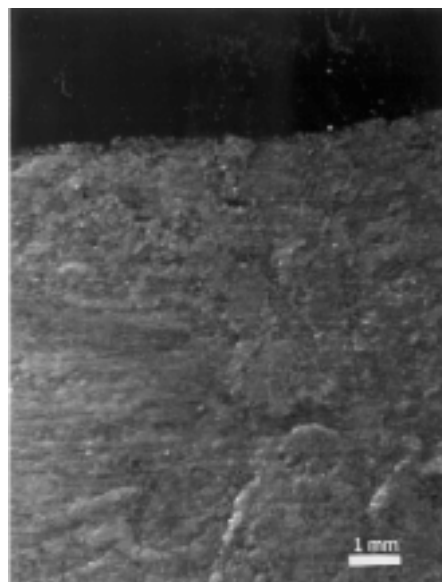
100-hr Salt Fog

500-hr Salt Fog

**Figure 4** - Typical surface appearance after salt fog exposure.

Optical examination of salt fog corroded surfaces revealed generally that only slight general corrosion and pitting, typically 0.05-0.10 mm (0.002-0.004 in) deep, had occurred after 100 hour exposure. After 500 hour exposure, severe general corrosion and pitting, typically 0.12-0.25 mm (0.005-0.010 in) deep, had occurred. Figure 4 shows macrophotographs of typical surfaces after 100 and 500 hour salt fog exposures.

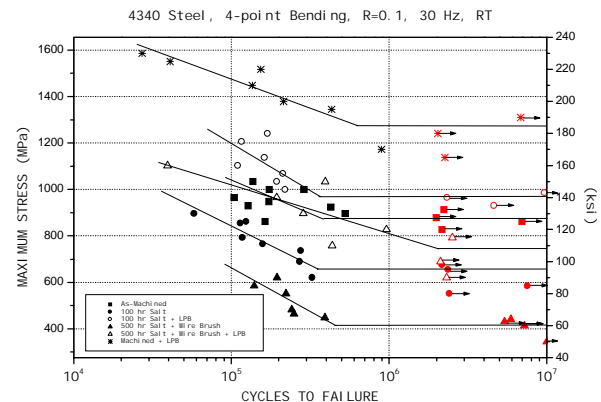
Figure 5 - High cycle fatigue S/N Data

Figure 5 shows fatigue S-N curves generated from specimens having six different surface conditions. These were:

*As machined (end milling-end cutting)*  
*Machined + LPB*  
*Machined + 100-hr. salt fog exposure*  
*Machined + 100-hr. salt fog + LPB*  
*Machined + 500-hr. salt fog exposure*  
*Machined + 500-hr. salt fog + LPB*

As seen in Figures 4 and 5, LPB treatment increased long-life fatigue strength approximately 30 percent relative to the as machined condition at all cyclic lives. This increase is attributed to delay in crack initiation and retardation of fatigue crack growth by the residual compressive stresses induced in surface and subsurface layers by LPB.

As would be expected, corrosion on machined surfaces reduced fatigue resistance. As revealed in Figure 5, salt fog corrosion exposures greatly reduced fatigue strength relative to the machined condition at all cyclic lives. Fatigue strength reductions relative to the as machined condition of 30-35 percent and 45-55% were observed in specimens exposed for 100 and 500-hrs. respectively.

LPB treatment after corrosion exposure greatly improved the fatigue strength of corroded surfaces. For the 100-hr. exposed condition, the improvement was nearly 50 percent, giving fatigue strength at  $10^7$  cycles more than 10 percent greater than for the original machined condition. The 60 percent fatigue strength improvement by LPB for the 500-hr. exposed condition was also quite marked; however, the strength level after LPB remained 25 percent less than for the original as machined condition. Apparently, compressive stresses from LPB tend to delay and retard crack initiation and progression in corrosion damaged; however, not to the full extent exhibited by LPB treatment on a relatively undamaged, machined surface.

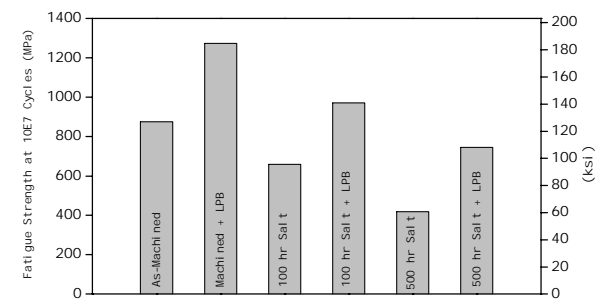
Figure 6 - Long life fatigue strength (4340 Steel).

For convenience in visualizing fatigue strength differences, maximum stress values at  $10^7$  cycles for each surface condition are presented in bar chart form in Figure 6.

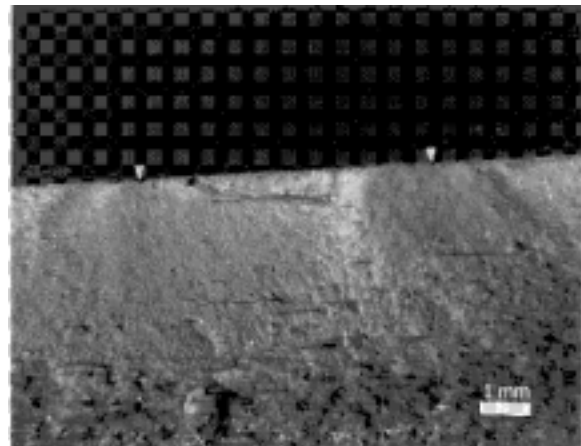
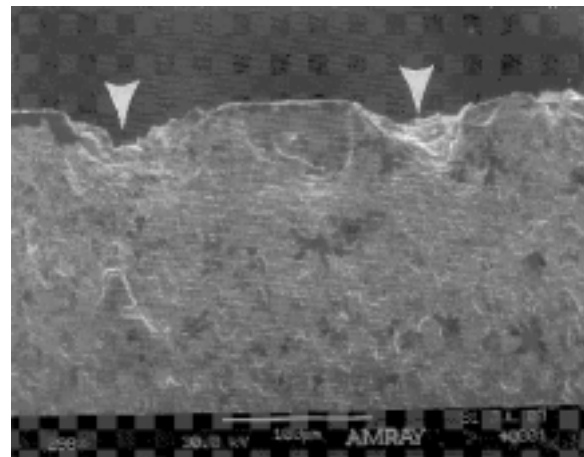
(a) Optical

(b) SEM

**Figure 7** - Fatigue origins in two LPB treated, 100 hr. salt fog exposed specimens.

Fatigue fractures in all specimens were examined optically at magnifications to 40x to ascertain fatigue origin locations relative to processed surface areas and to determine if any extraneous features or anomalies had influenced failure. In general, all fatigue failures occurred within specimen gage sections and within representatively processed surface areas. All fatigue origins occurred at specimen surfaces insofar as could be observed optically. This is not surprising because the applied stress bias of the four-point bending,  $R = 0.1$  testing mode would inherently favor surface fatigue origins. All machined and LPB treated machined specimens exhibited single fatigue crack origins. Multiple fatigue initiation sites were observed generally in salt fog corroded specimens and LPB treated corroded specimens. These sites were at corrosion pits even in the case of the LPB treated specimens despite their significantly

greater fatigue strengths relative to as corroded untreated specimens. This was in contrast to observations made in a previous similar investigation on 7075-T6 aluminum alloy<sup>10</sup> wherein fatigue origins in LPB treated specimens occurred subsurface remote from corrosion pits having the same order of depths as those observed in the current investigation. In that previous work, full rather than partial restoration of fatigue strength from LPB after both 100 and 500-hr. exposures was achieved. From this it is apparent that not all degrees of corrosion damage in steel can be fully mitigated by LPB notwithstanding that pits were only 20 percent or less than the LPB depth of compression.

A few specimens were selected for higher magnification fractographic observation via scanning electron microscopy (SEM). As-machined and LPB treated machined specimens exhibited single fatigue origins at specimen surfaces, confirming optical observations. No anomalous surface or subsurface features were noted. Also confirming optical observations, fatigue origins in as-corroded and LPB treated corroded specimens were from corrosion pits. Figure 7 is an exemplary micrograph of fatigue origins in an LPB treated, 100 hour exposed specimen. Corrosion pits were observed to be approximately hemispherical in shape. Figure 8 is an exemplary micrograph showing multiple fatigue initiation sites at the boundary of a pit in an LPB treated, 500-hr. exposed specimen.

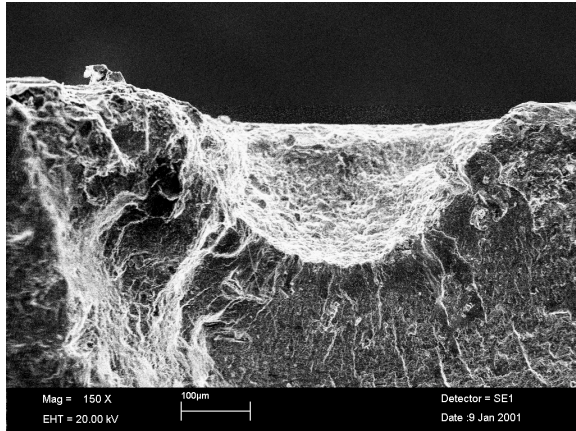
**Figure 8** - Multiple microscopic fatigue origins from corrosion pit in LPB treated, 500 hr. salt fog exposed specimen.
